EXHIBIT 7

TECHNICAL SERVICE BULLETIN

Bulletin Number: A-17-01-A

2015–2016 Sportsman Touring 850/1000 Thermal Protection Update

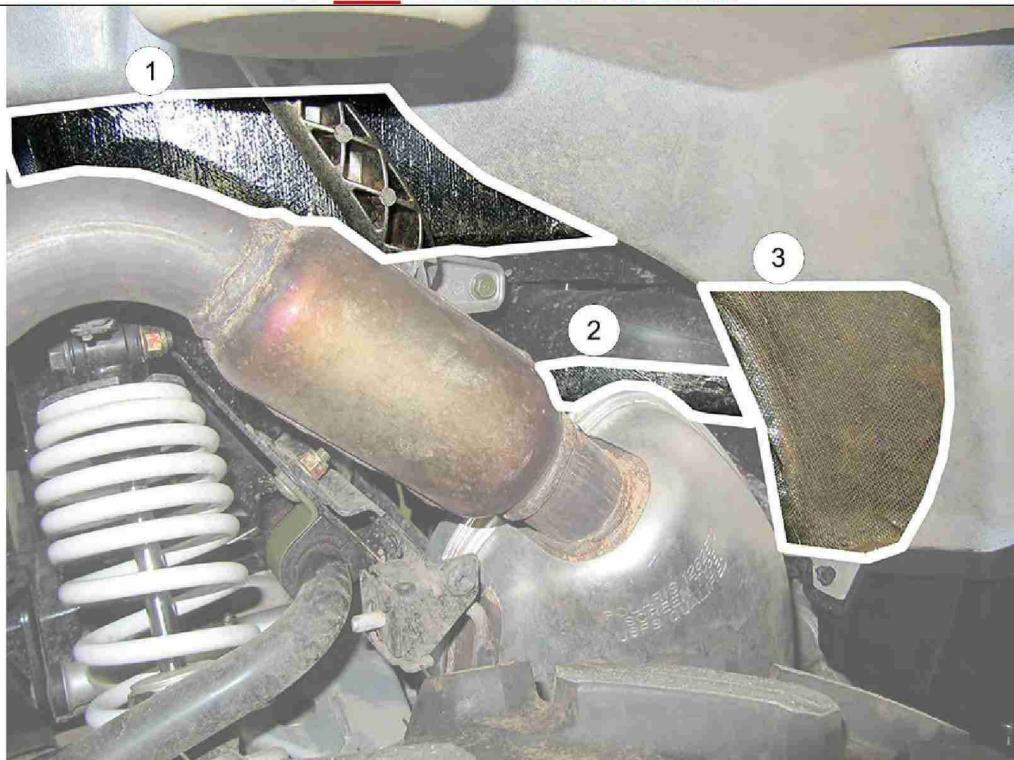
PHOTO 1 - 1000 Touring

Do NOT remove these shields!

① Seatwell Foil Heat Shield 5814246

② Clutch Duct Heat Shield 5814214

③ Rear Cab Foil Heat Shield 5814215
